OPERATION SNAPPER

Project 8.5

INCENDIARY EFFECTS OF ATOMIC BOMB TESTS ON BUILDING SECTIONS AT YUCCA FLAT

REPORT TO THE TEST DIRECTOR

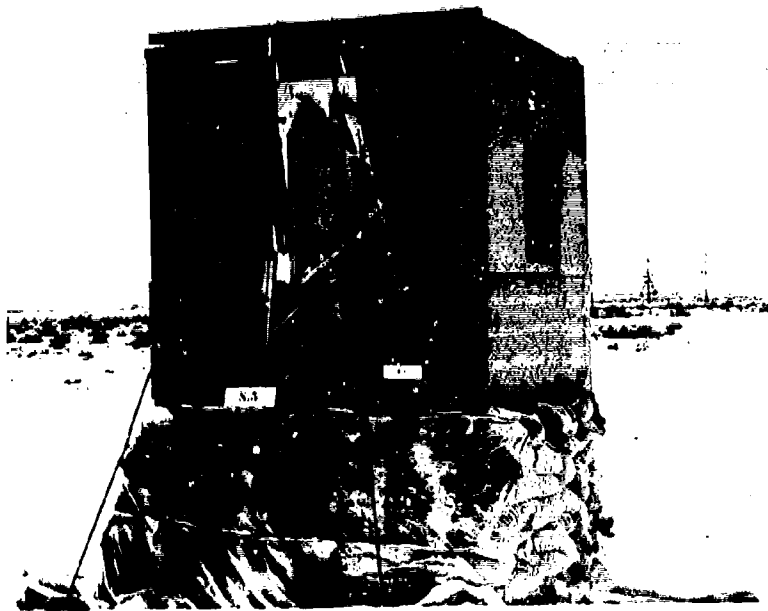
No sustained fires were set in the three rooms exposed to Shot 3. The pigmented cloth window shade of ecru color was ignited only at the 7000-foot station, but there is no evidence that the fire continued after the blast. The white cheesecloth window curtain was only very slightly scorched at 7000 feet, and unaffected by the thermal radiation at 10,000 and 13,000 feet. The heavy cotton cloth of exposed sandbags and an unbleached sheeting, used at some stations to protect the sandbags, were burned or charred out to 10,000 feet from ground zero and slightly scorched at 12,000 feet (Fig. A.5).

Fig. A.5. Room at 7000-ft Station After Shot 3.
Shade, front wall, and sheeting covering
sandbags charred. No sustained burning.

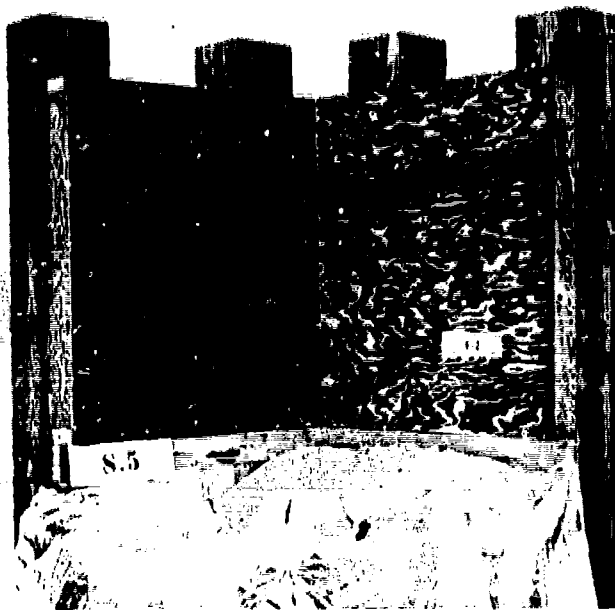
The excelsior caught fire and burned at 7000 feet (Figs. A.6 and A.7) but not at 13,000 feet. At 10,000 feet the excelsior burned completely at the base of the cornice (Fig. A.12); at the base of the wall corner it was ignited but soon extinguished (Fig. A.11). Where the excelsior burned completely, the fire in the wood structure continued 2.3 and 3.5 minutes after the blast wave and burned deeply into the face of the panels and the under-side of the cornice to a depth of 1/16 to 1/8 inch before dying out.

Fig. A.6. Wall-corner Sections at 7000-ft with (bottom) and without (top) Excelsior, After Shot 3. Douglas-fir plywood and posts singed. Excelsior burned, charring the plywood deeply.

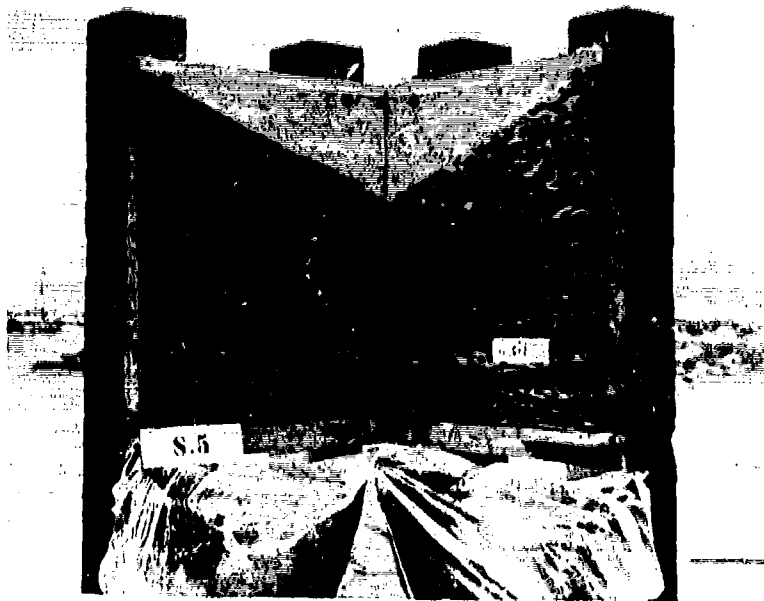
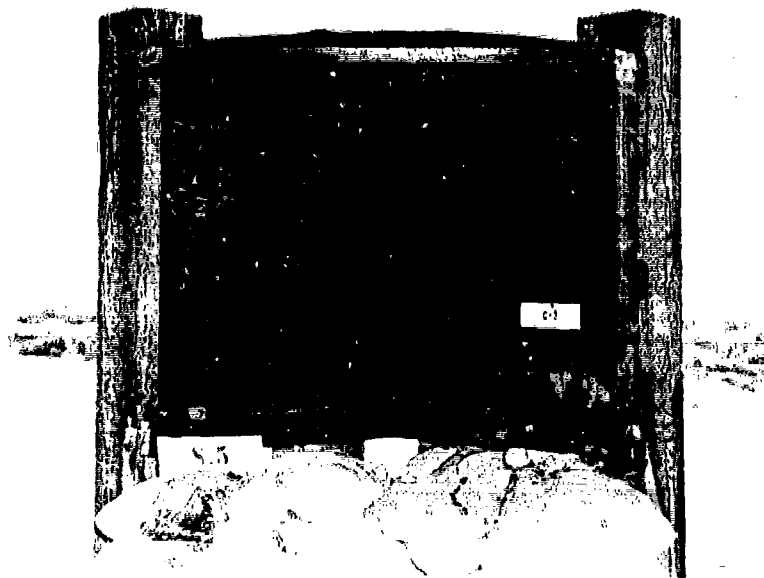
Fig. A.7. Cornice-corner Sections at 7000-ft with (bottom) and without (top) Excelsior, After Shot 3. Plywood and posts singed. Plywood deeply burned by fire in excelsior.

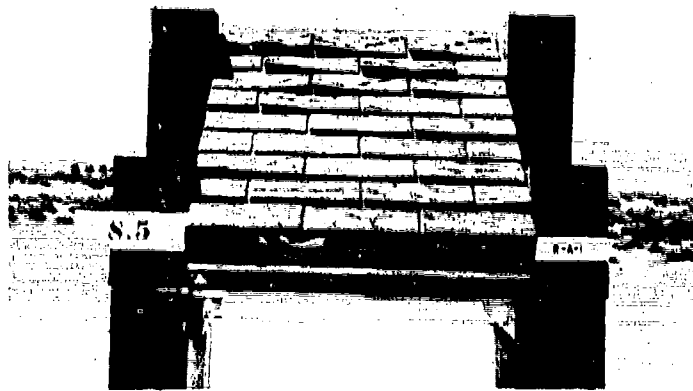
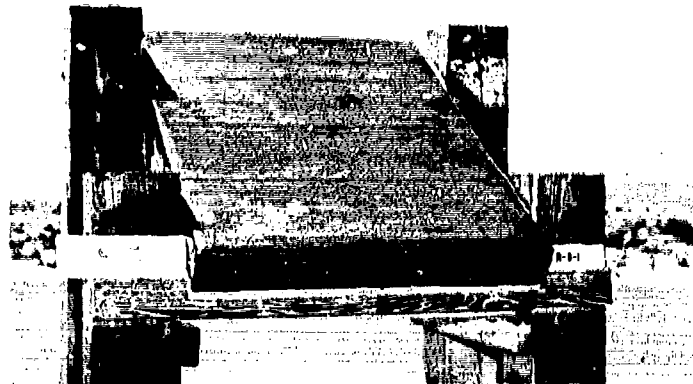
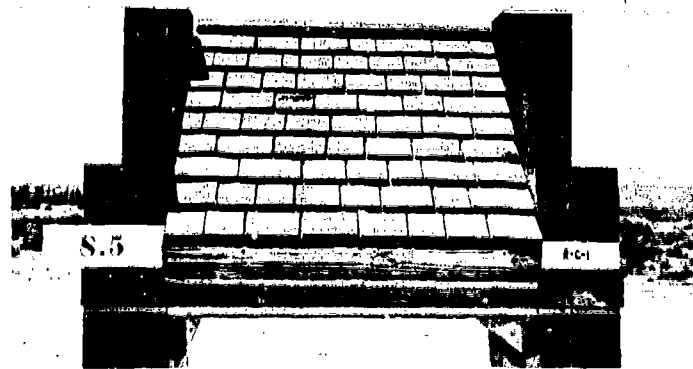
None of the roof sections caught on fire, and in no case was there loss of serviceability as a roof. The asphalt of the shingles and built-up roof sections melted and flowed at all distances tested. The cedar shingles were charred but did not burn. The depth of char in the wood shingles at 7000 feet was estimated to be a few tenths of a millimeter, but at 13,000 feet the surface was only slightly darkened.

Fig. A.8. Asphalt Shingle, Built-up Asphalt, and Cedar Shingle Roof Sections at 7000-ft after Shot 3. Asphalt shingles bent; wood shingles blackened; surface asphalt melted and flamed.

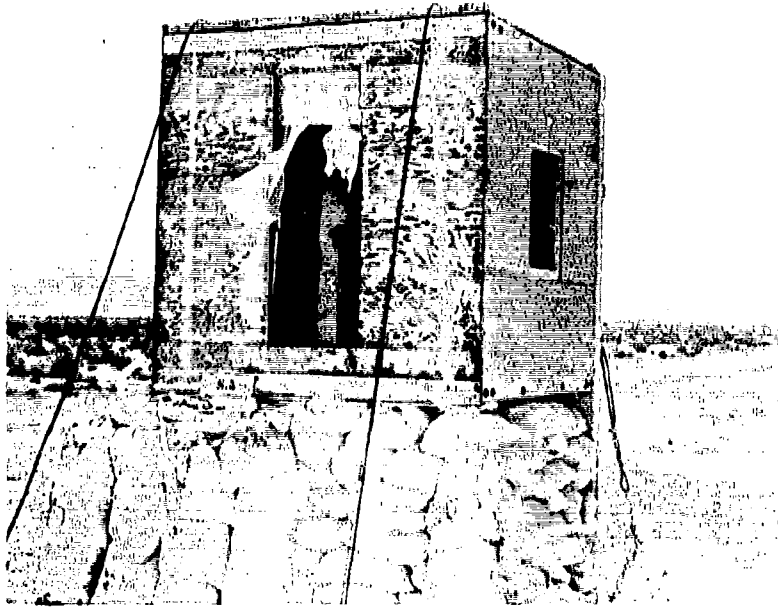
Fig. A.9. Room at 10,000-ft After Shot 3. Front wall singed. Sheeting covering sandbags burned away.

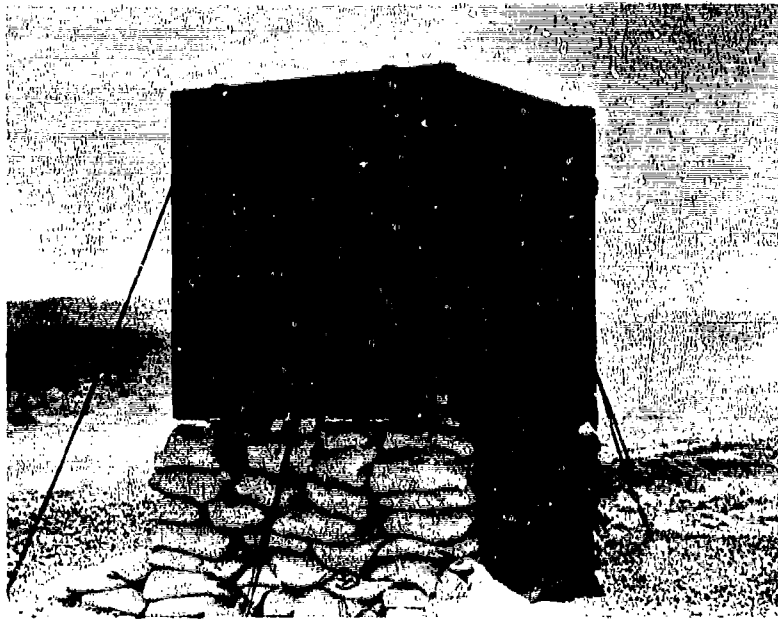
Fig. A.10. Room at 13,000-ft After Shot 3. No thermal damage.

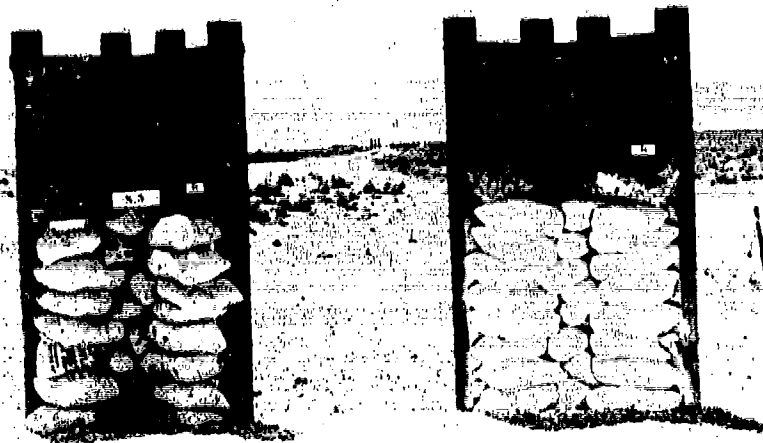
Fig. A.11. Wall-corner Sections at 10,000-ft After Shot 3.
Two spot fires of short duration in the excelsior.

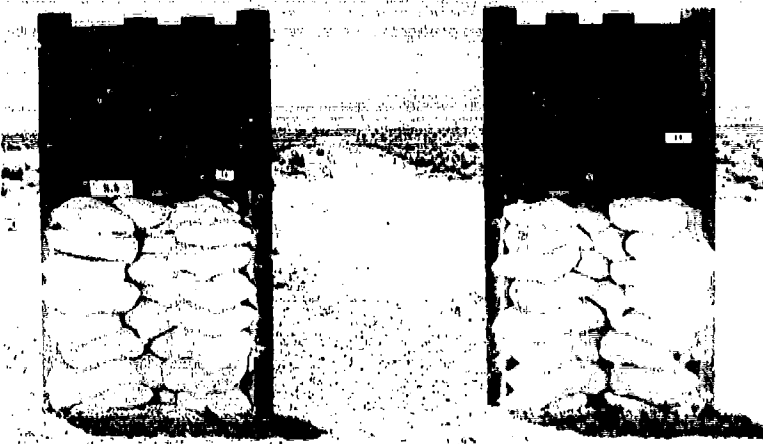
Fig. A.12. Cornice-corner Sections Exposed with and without
Excelsior to Shot 3 at 10,000-ft Station. Ply-
wood on right deeply burned by fire in excelsior.

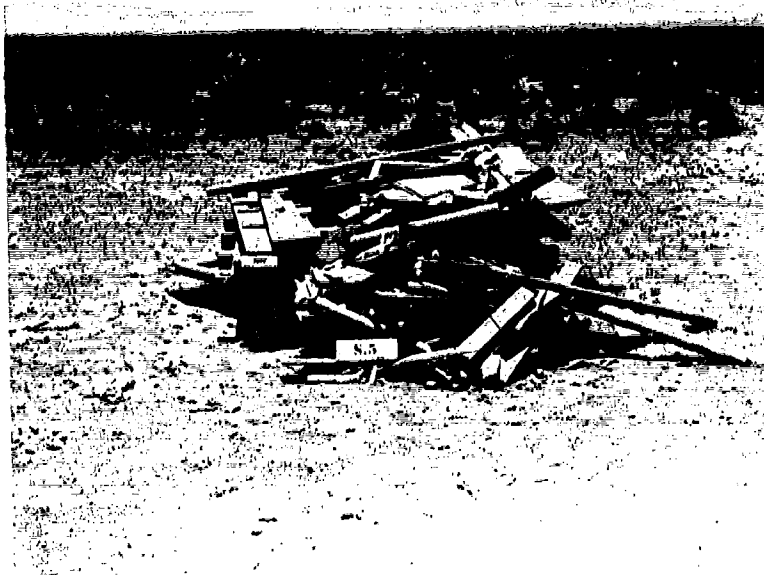
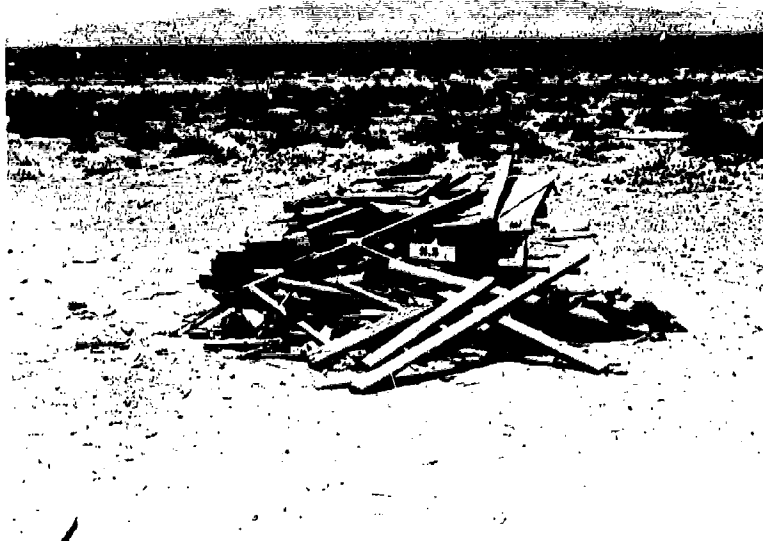
Fig. A.17. Scrap Pile of Wood at 7000-ft Station Before (top) and After (bottom) Shot 4. Exposed wood singed; pile disarranged; no burning.

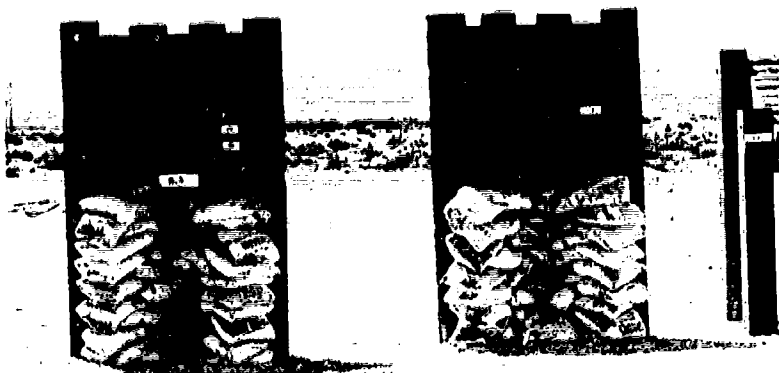
At 7000 feet the excelsior was ignited and consumed (Fig. A.18). At 8000 feet fine tips of the excelsior were charred and two spot fires were started, but the excelsior did not burn completely (Fig. A.19). At 10,000 feet only a few fine tips were discolored.

Fig. A.18. Cornice-corner at 7000-ft After Shot 4.
Plywood singed; sandbags charred in spots;
excelsior set afire.

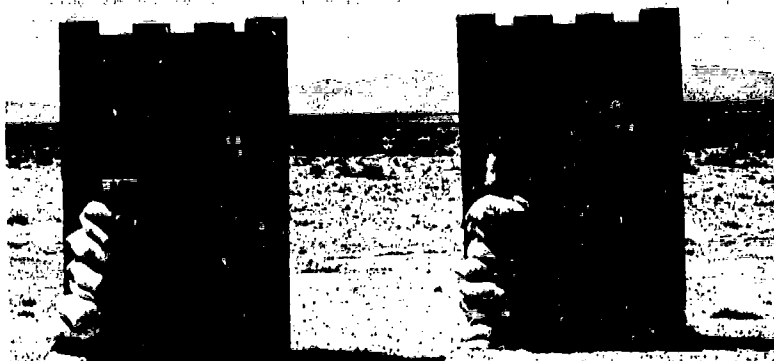
Fig. A.19. Cornice-corner at 8000-ft After Shot 4.
Plywood singed; excelsior tips burned;
two brief spot fires in the excelsior.
